## Home Inspection Report

PROPERTY INSPECTED:  
**24 Heale Avenue**  
Toronto, ON M1N 3X7

Date of Inspection: 12/23/2024

Inspection No. 141465-1208

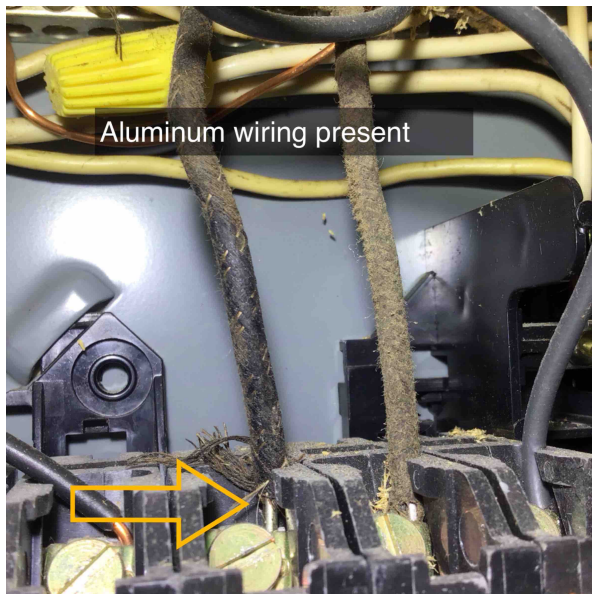
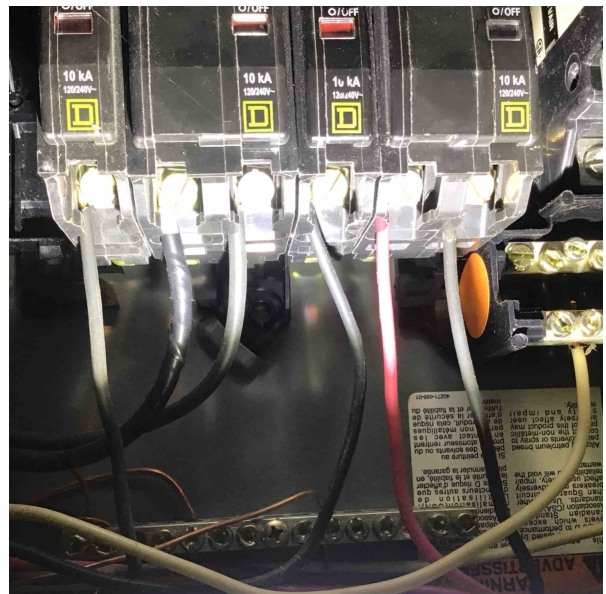
8.8.2 Aluminum and copper wiring was found upon review of the electrical panel. A qualified electrician should further assess and correct as required for electrical safety. **(Electrical Closet / Offset)**

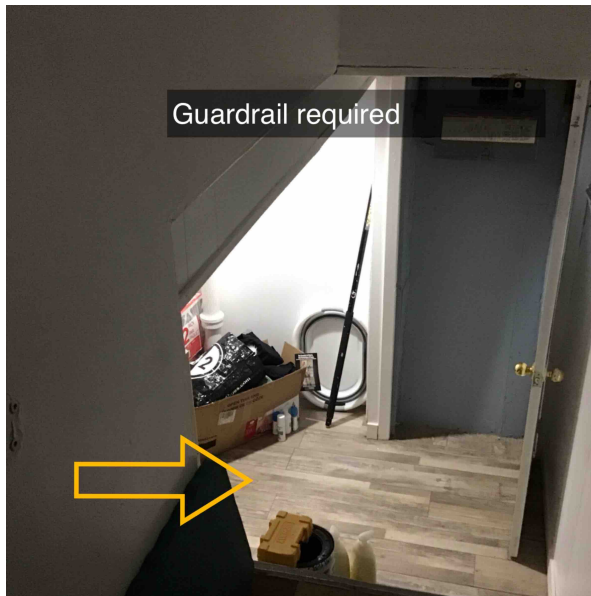
11.6.2 The guardrail is missing. Install a guardrail for health and safety. **(Stairwell to Basement)**

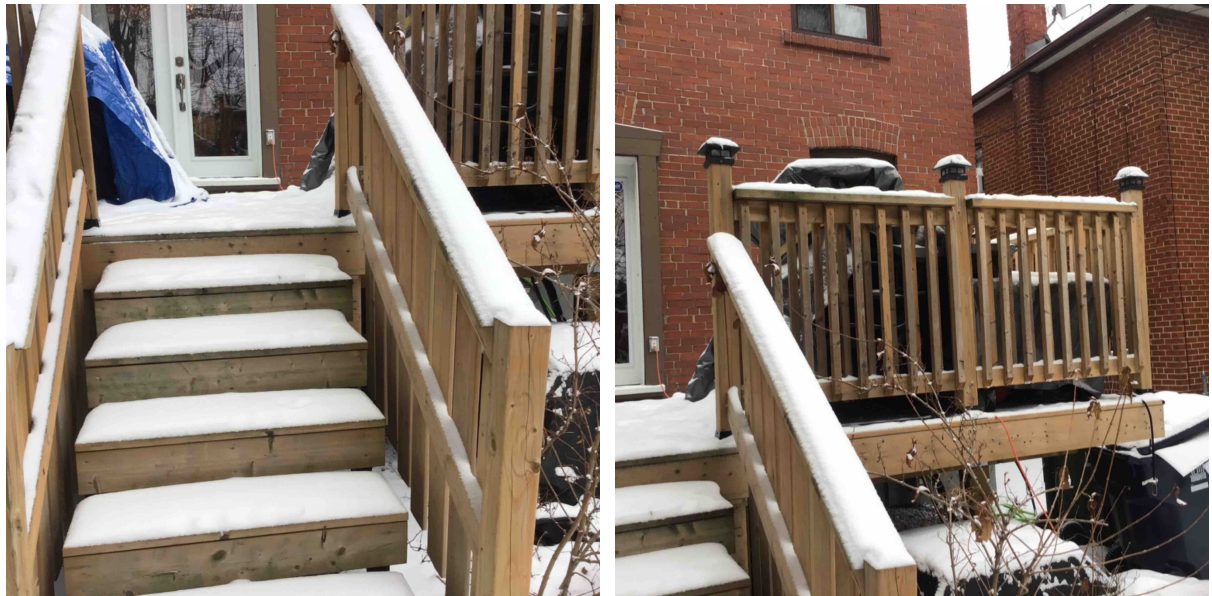
3.10.1 The dwelling has an elevated and upgraded rear deck system (**Exterior - Rear**)

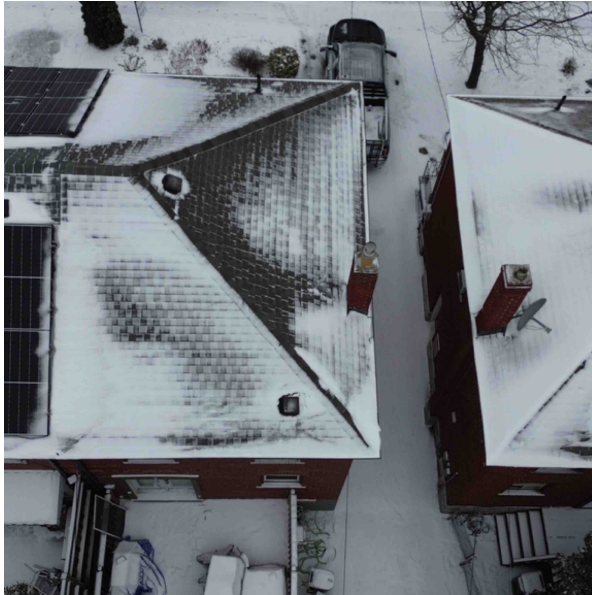
4.2.3 The roof has the appearances of being replaced recently with a premium laminate / architectural grade shingle. There are suitable amounts of roof venting, and the metal flashings have been updated.

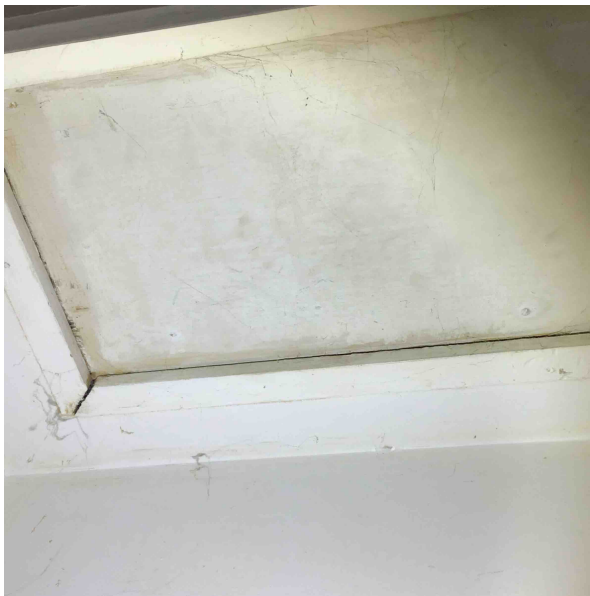
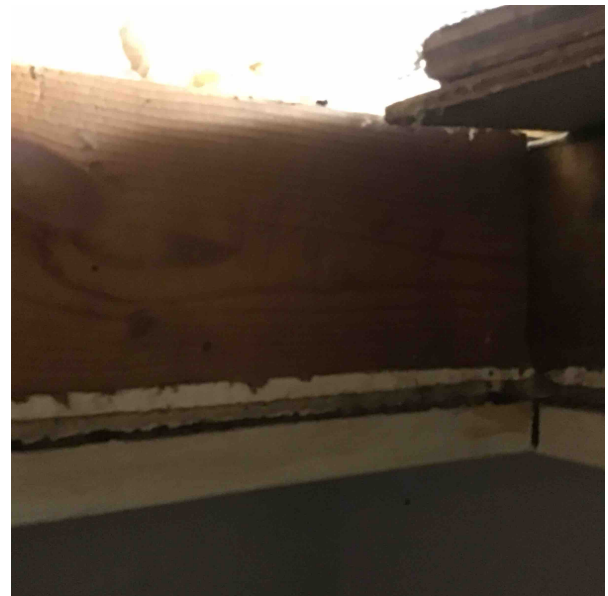
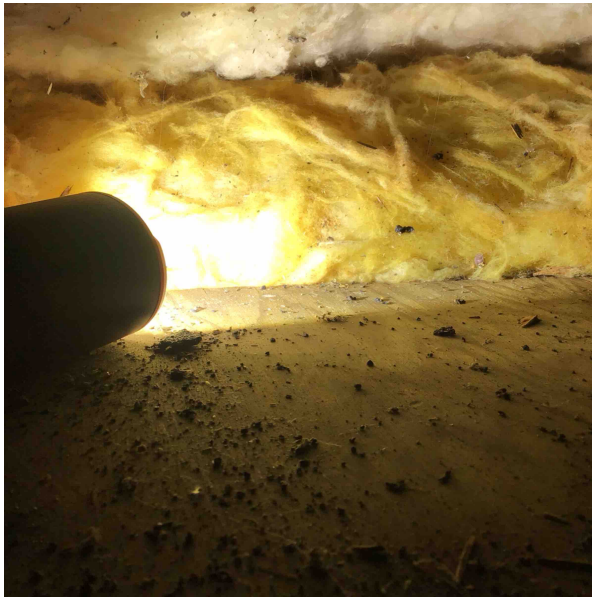
5.3.3 We suggest that the attic hatch be enlarged to allow better access to the attic areas. Current standards are 550 mm by 900 mm

The access hatch requires weather stripping to stop heat loss and transference of humidity into the attic

We suggest that the attic hatch have additional insulation applied for increased energy efficiency (**Bedroom - Front**)

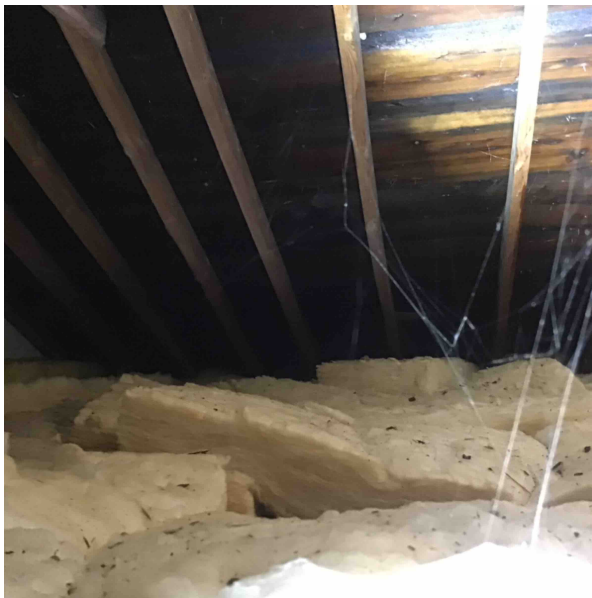
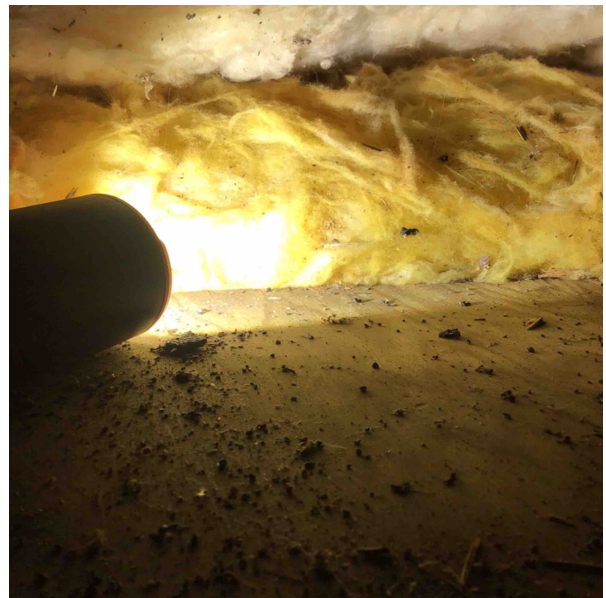
5.4.3 Insulation levels encountered were at levels typical for a dwelling of this age. We would suggest that additional insulation be applied for optimal energy efficiency.

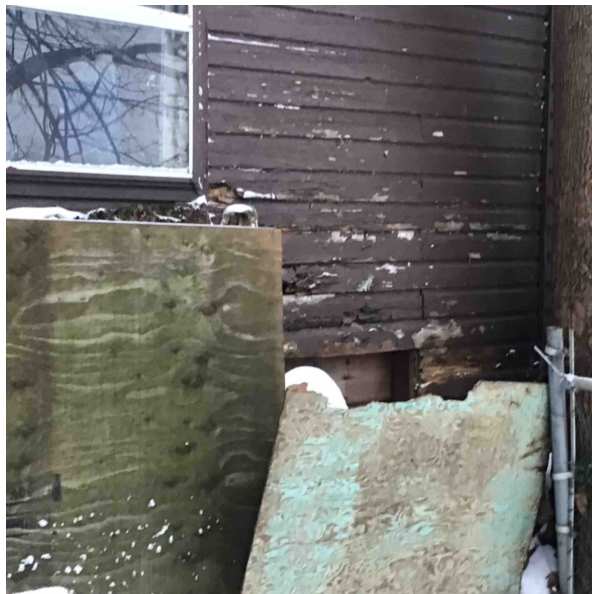
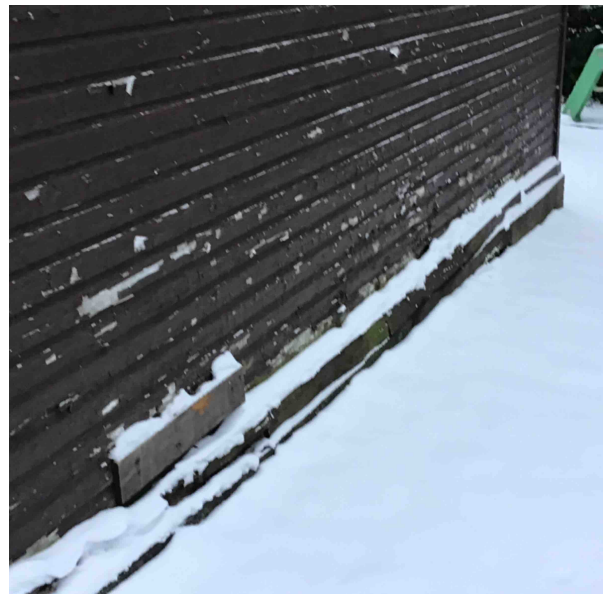
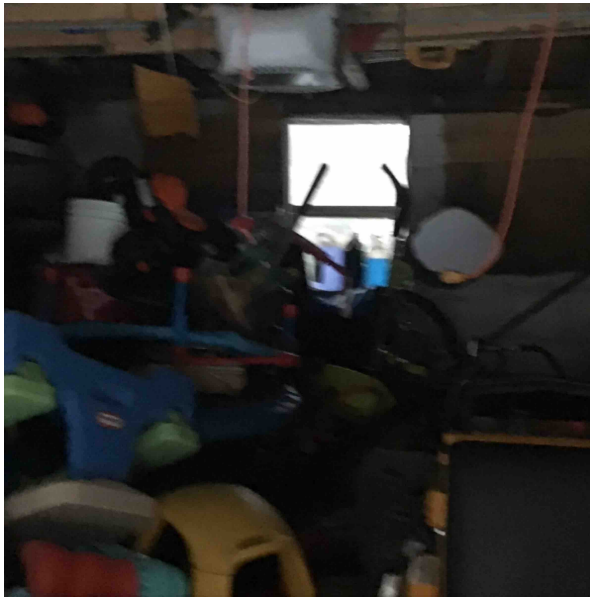
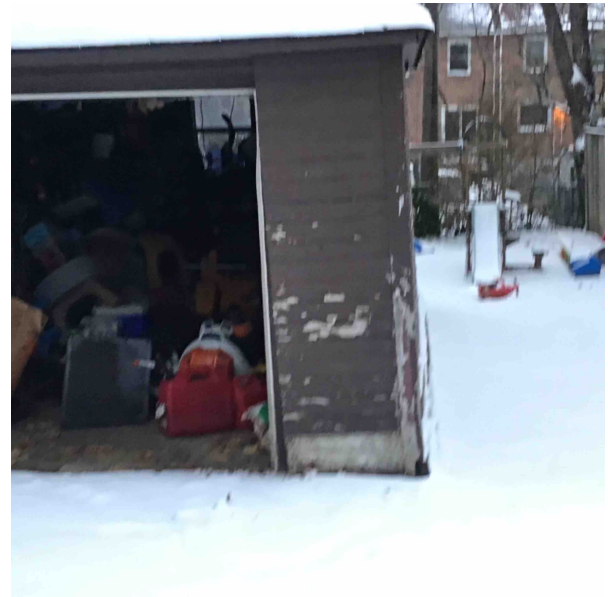
6.3.1 The garage is in general disrepair, as is typical of many similar detached garages. Repair and maintain as needed to the level of functionality that you need. Extensive improvements would likely justify rebuilding the structure.

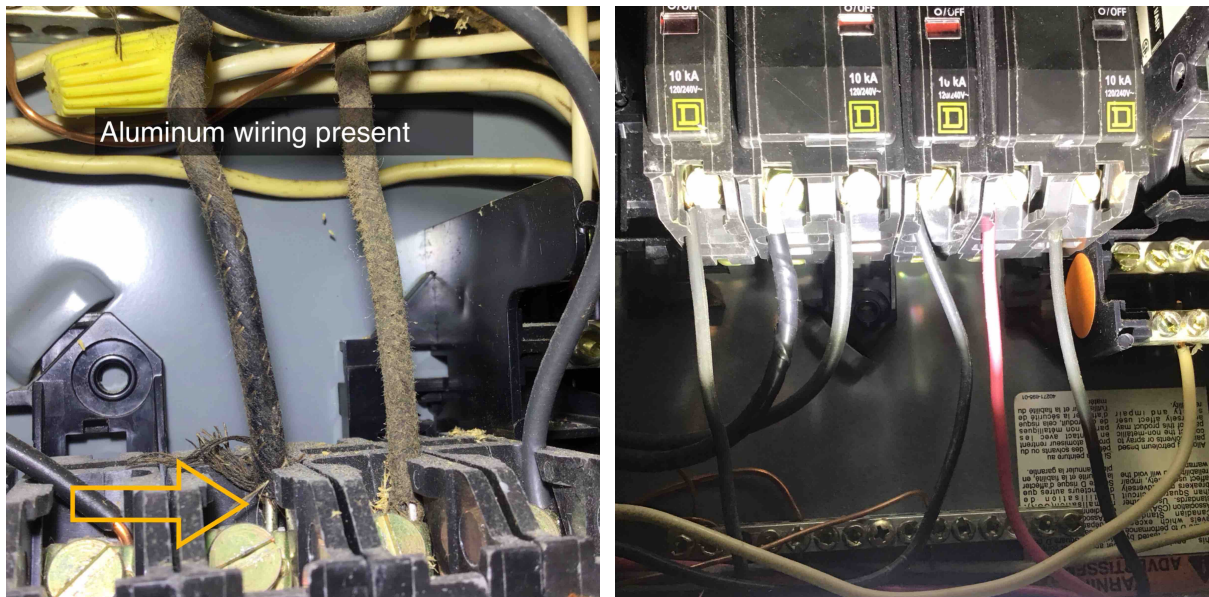
8.8.2 **Aluminum and copper wiring was found upon review of the electrical panel. A qualified electrician should further assess and correct as required for electrical safety. (Electrical Closet / Offset)**

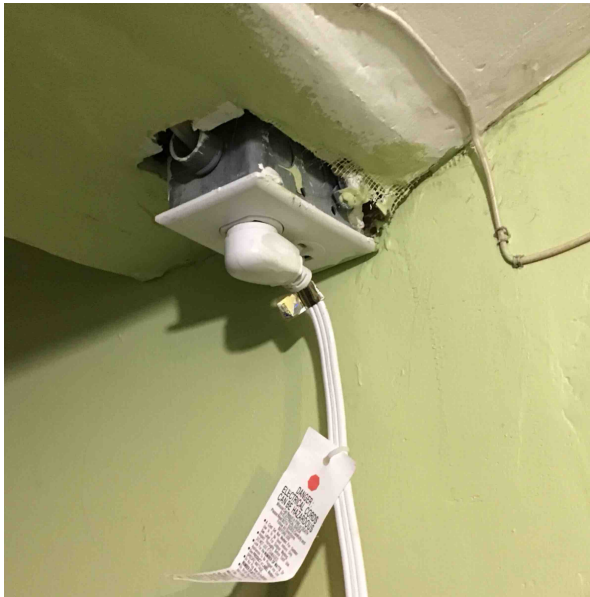
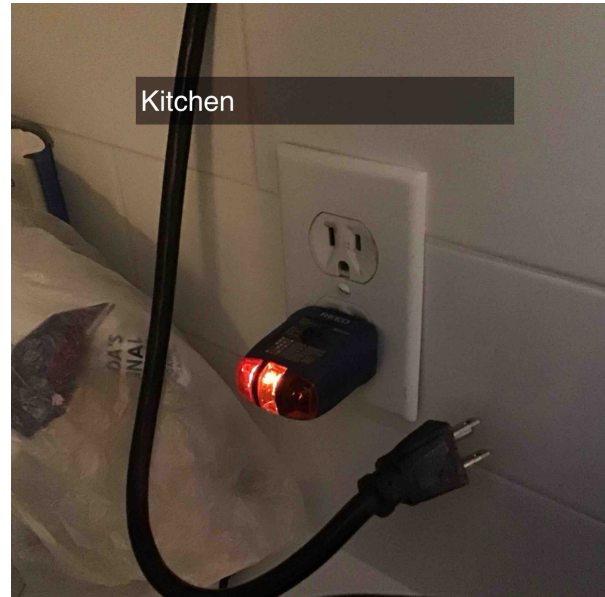
8.12.2 The GFCI(s) are missing. A qualified electrician should further assess and correct as required for electrical safety.

- Kitchen
- Laundry

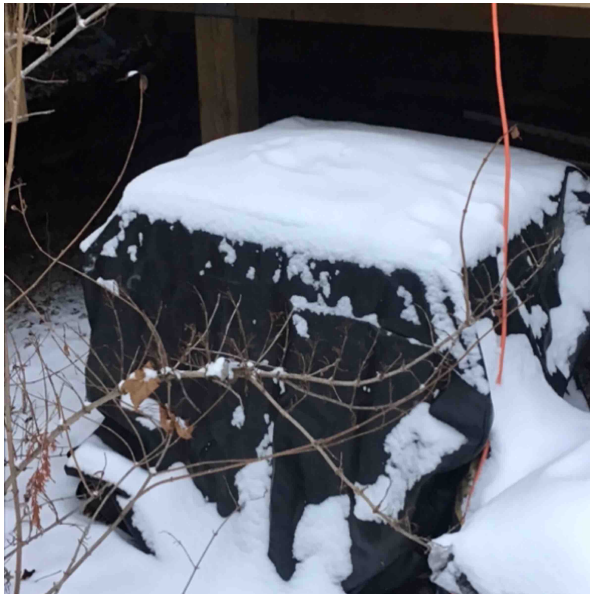
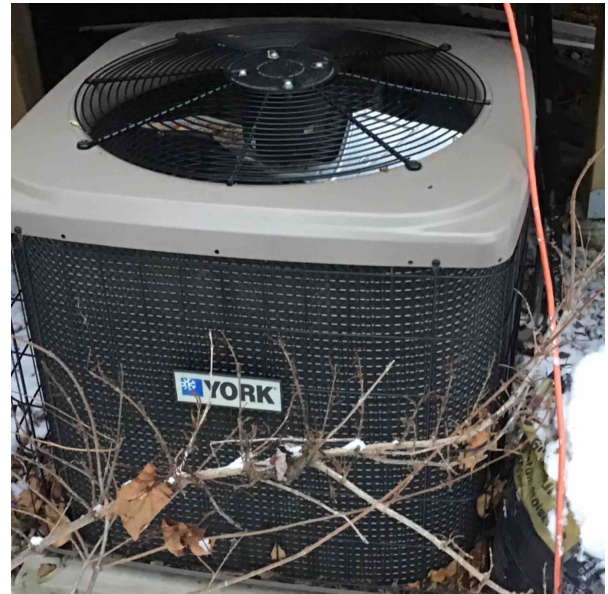
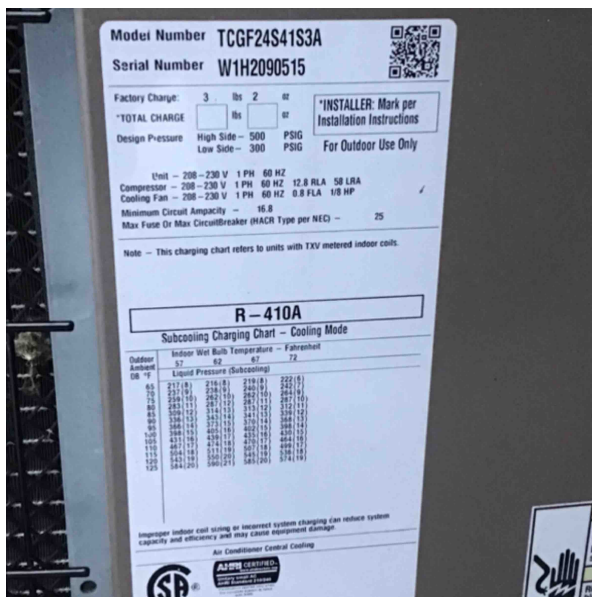
9.6.1 Air Conditioner is between the middle and end of its lifespan

9.6.2 We were unable to test the air conditioning system as the exterior temperature was below 15 degrees or the system had been winterized for the season. We are unable to guarantee the functionality of the system, and suggest that the system be inspected as temperature permits. (Exterior - Rear)

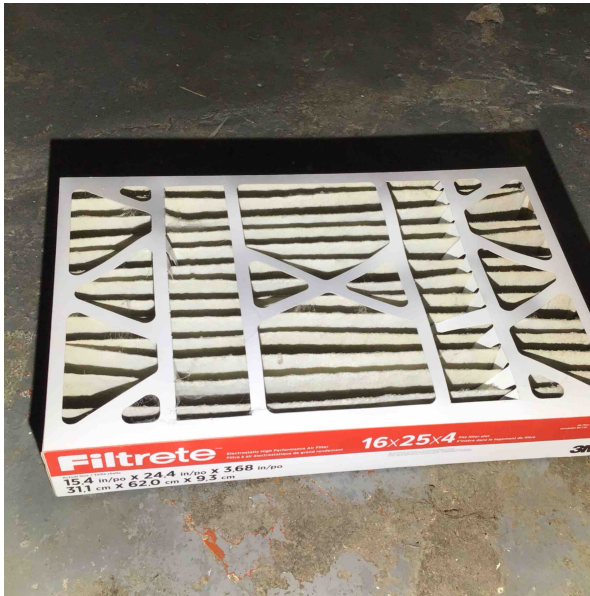
9.11.4 We would suggest that the furnace filter be changed or cleaned upon occupancy and quarterly inspections be performed. Dirty filters affect HVAC lifespan. **(Mechanical Room / Utility Room)**

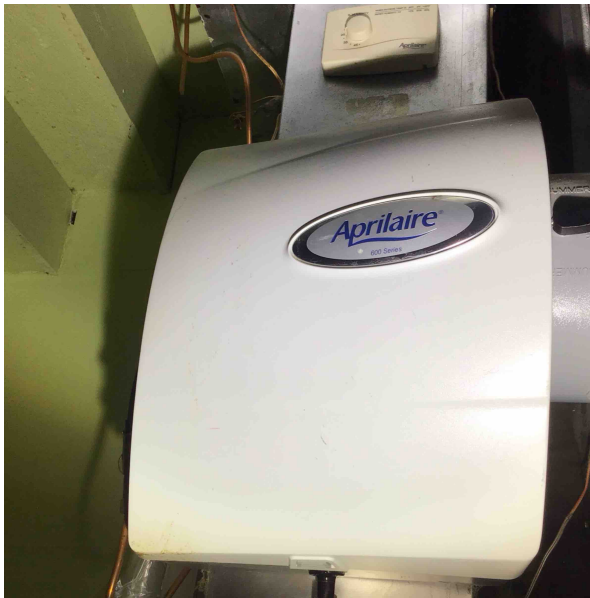
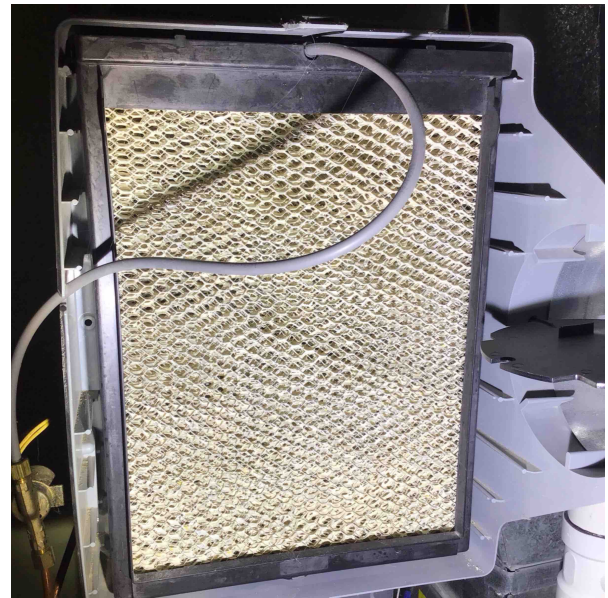
9.12.3 The HVAC system included a trickle humidifier that resolves winter dryness (**Mechanical Room / Utility Room**)

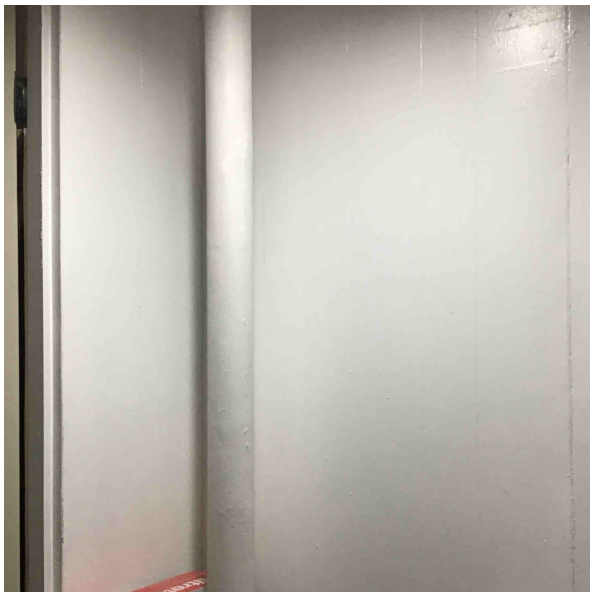
10.4.2 The drain, waste and vent piping is cast iron. A qualified plumber should further assess and upgrade / replace as required to prevent water damage due to cracking / corroding / pipe failure. (**Landing - Basement**)

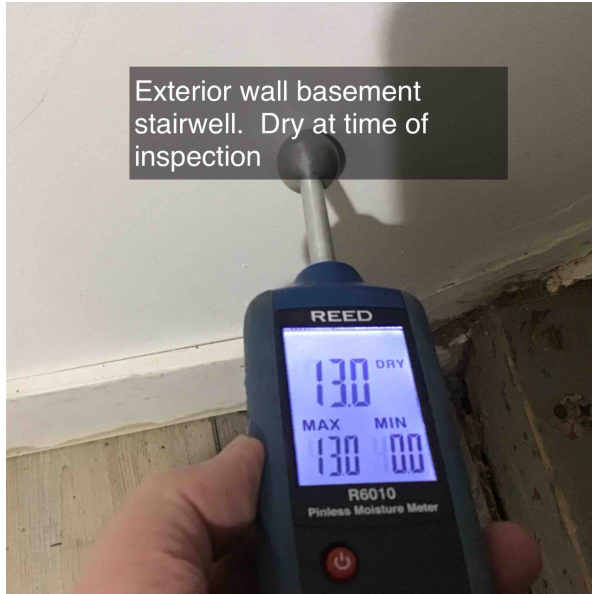
Exterior wall basement stairwell. Dry at time of inspection

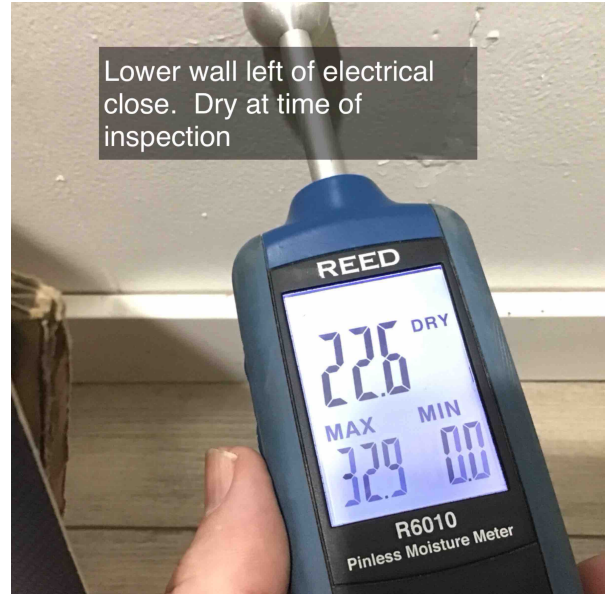
Lower wall left of electrical close. Dry at time of inspection

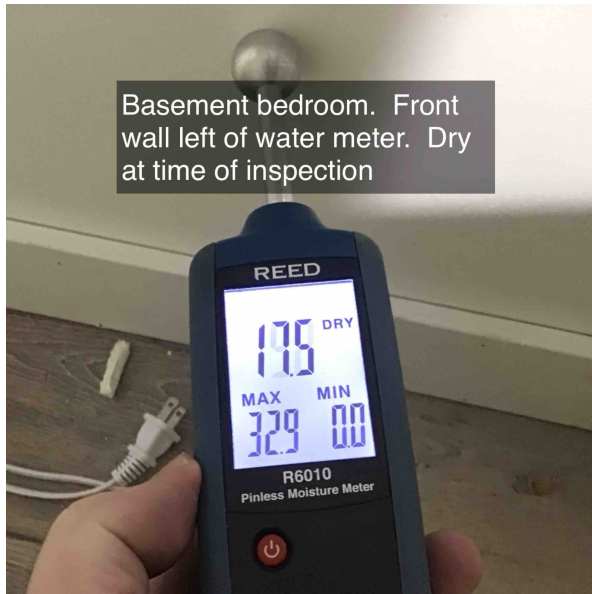
Basement bedroom. Front wall left of water meter. Dry at time of inspection

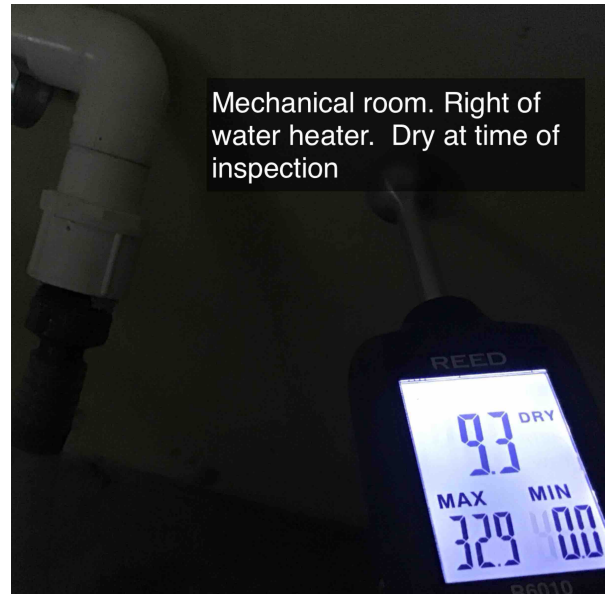
Mechanical room. Right of water heater. Dry at time of inspection

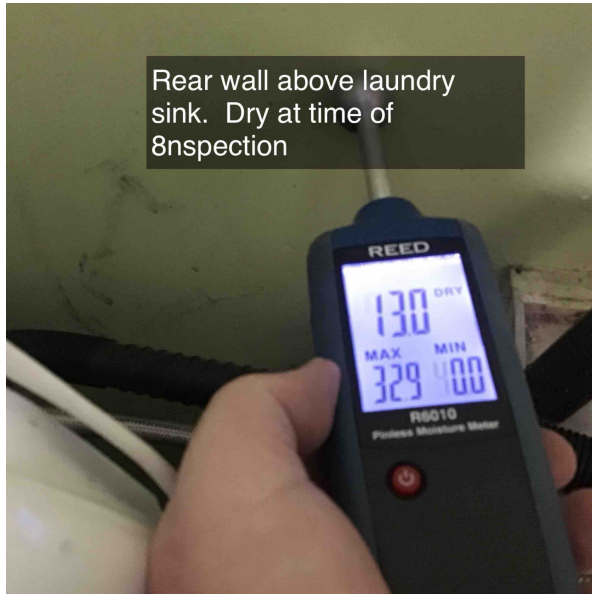
Rear wall above laundry sink. Dry at time of inspection

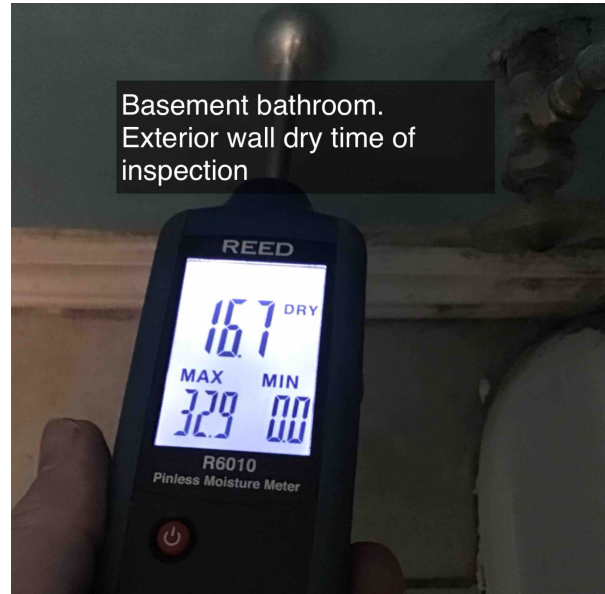
Basement bathroom. Exterior wall dry time of inspection

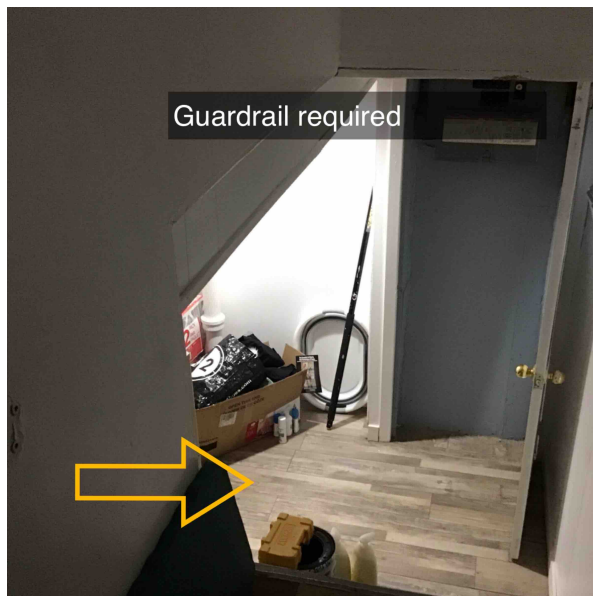
11.6.2 **The guardrail is missing. Install a guardrail for health and safety. (Stairwell to Basement)**
