## Home Inspection Report

PROPERTY INSPECTED:  
**24 Heale Avenue**  
Toronto, ON M1N 3X7

Date of Inspection: 12/23/2024

Inspection No. 141465-1208

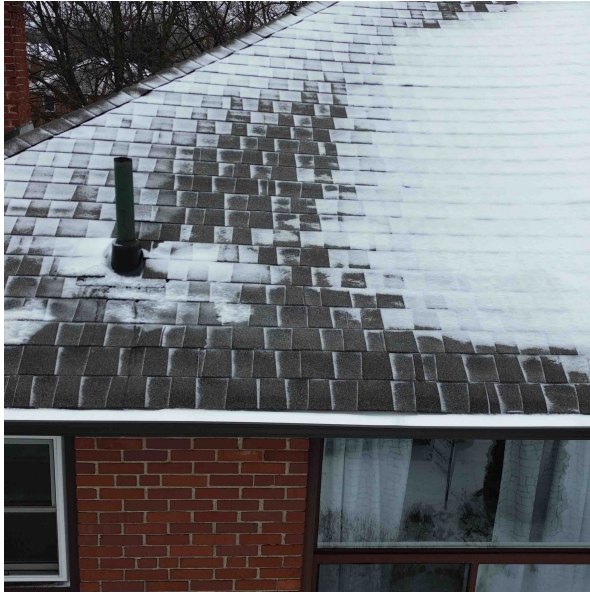
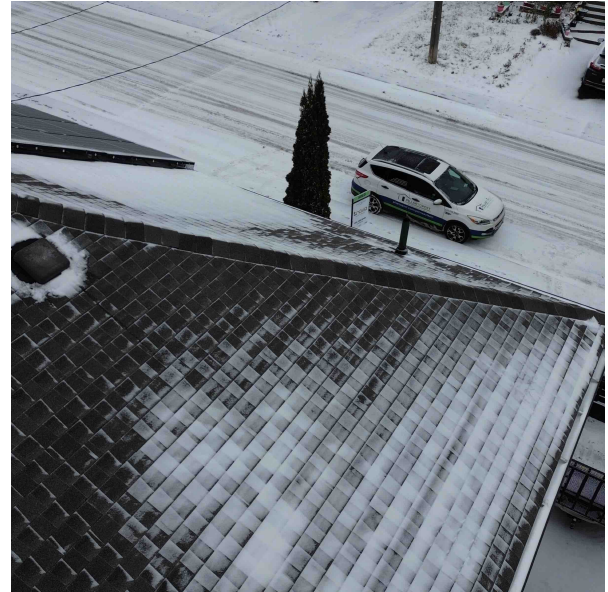
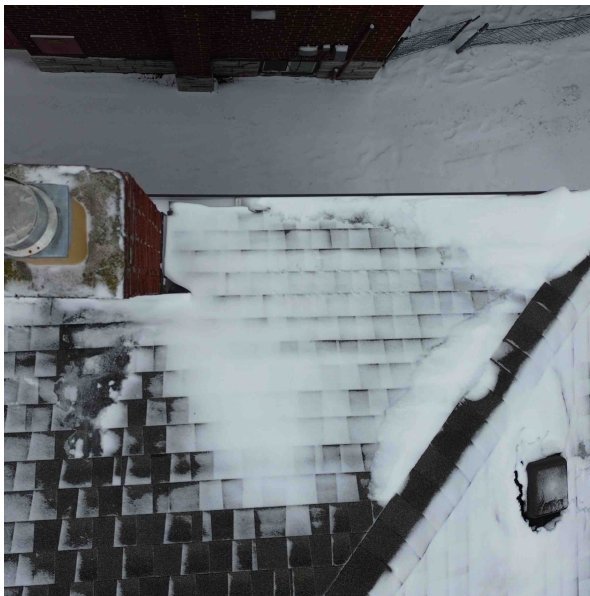
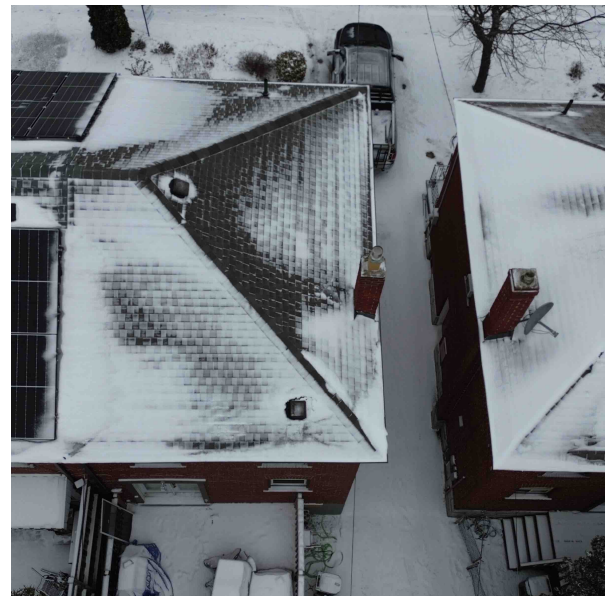
4.2.3 The roof has the appearances of being replaced recently with a premium laminate / architectural grade shingle. There are suitable amounts of roof venting, and the metal flashings have been updated.

4.4.1 The dwelling is covered with laminated shingles, also known as architectural roof shingles or three-dimensional shingles, are thick, double-layered fiberglass roofing shingles that offer a bold and visually striking aesthetic to the roof system.

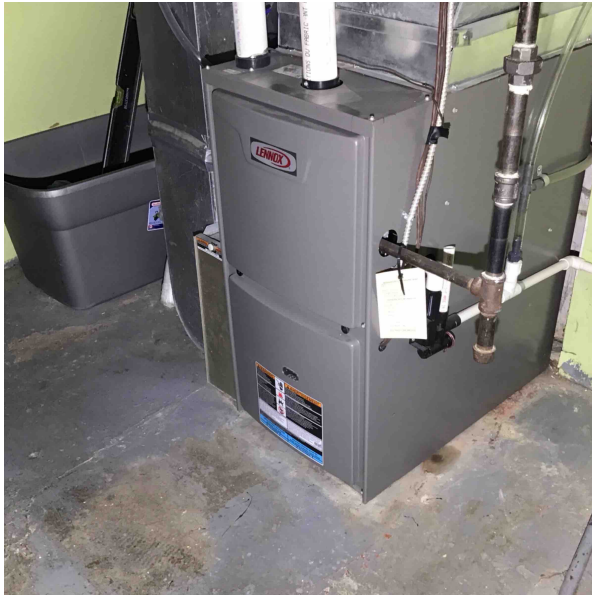
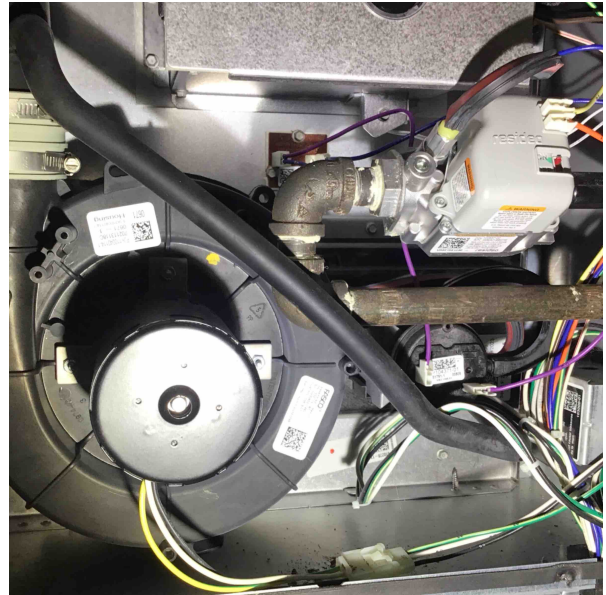
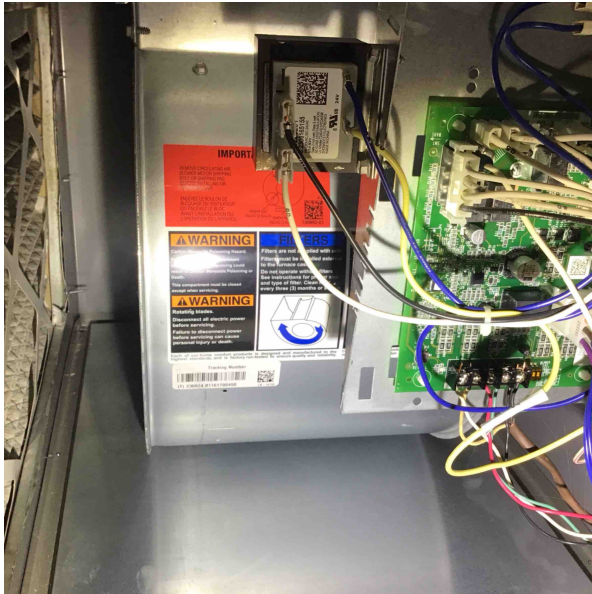
9.7.3 There is a new Lennox forced air furnace- Natural Gas (**Mechanical Room / Utility Room**)
